# Sony ILME-FR7

## Enabling VISCA over IP Communication

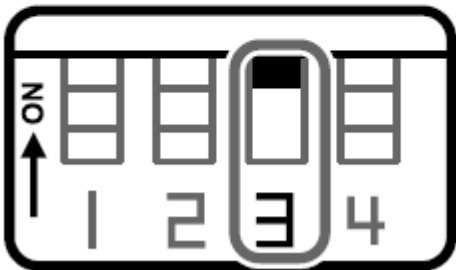
### SETUP

In order to connect to the SONY ILME-FR7/ILME-FR7K cameras, make sure you have VISCA enabled on the camera. This can be done by setting this DIP-Switch on the unit:

To use VISCA over IP communication with this unit, set SETUP switch 3 of the unit to the ON position to enable VISCA over IP communication. The switch setting is applied when the unit is next turned on.
